**IGLOO AND REVETMENT**

**NAVAL PROVING GROUND, ARCO, IDAHO**

**OCTOBER, 1946**

Army-Navy Explosives Safety Board 2029 Tempo 2 Building  
Washington, D. C.

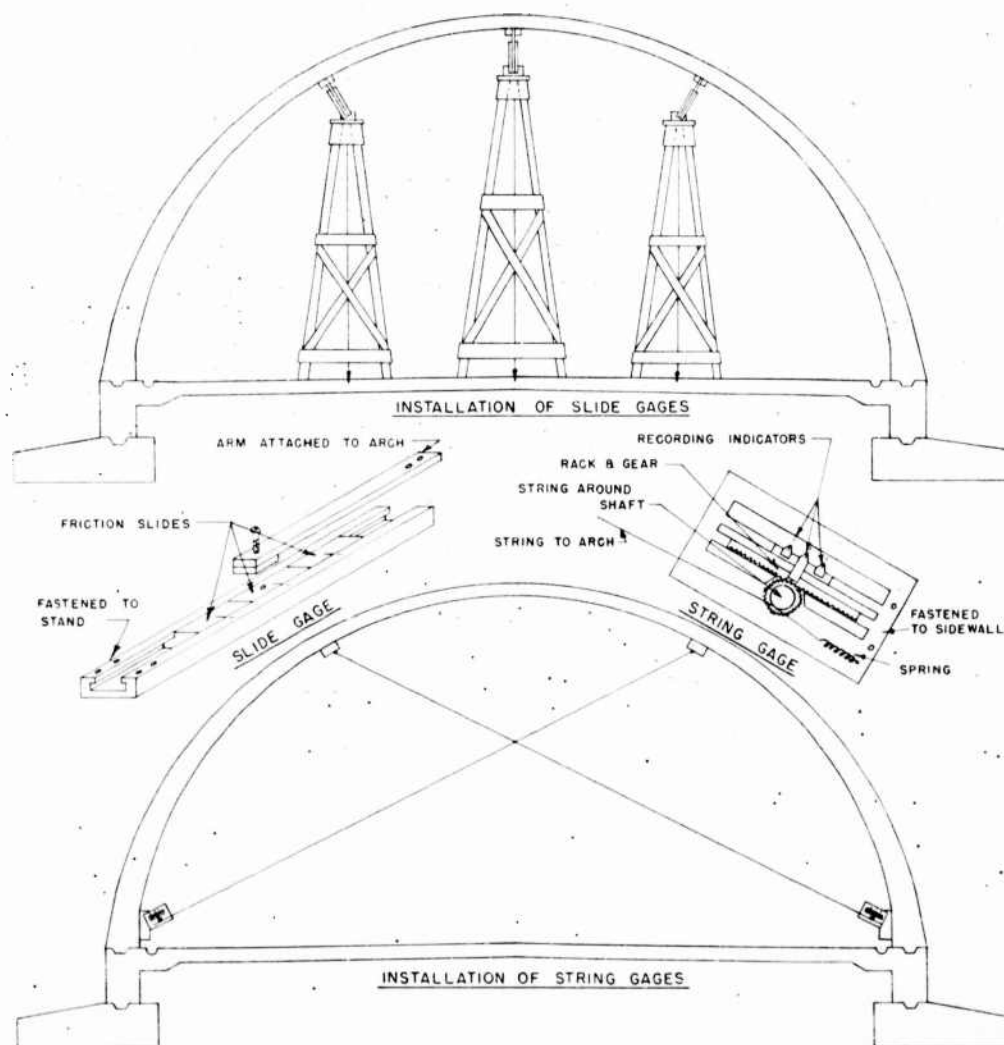
FIGURE 26. Deflection Gages, Tests 1 and 2

(e) *Transient displacement of target igloos.*—The slide and string gages also recorded the maximum transient changes in the dimensions measured, in either the positive or negative direction. It is recognized that both types of gages are subject to errors due to lost motion of parts, overdrive, elasticity of the wire used in the string gages, and other causes. Insofar as practicable, however, the mechanisms were designed to minimize such errors. The slide gage reading contains a component due to floor heave or subsidence as well as that due to arch

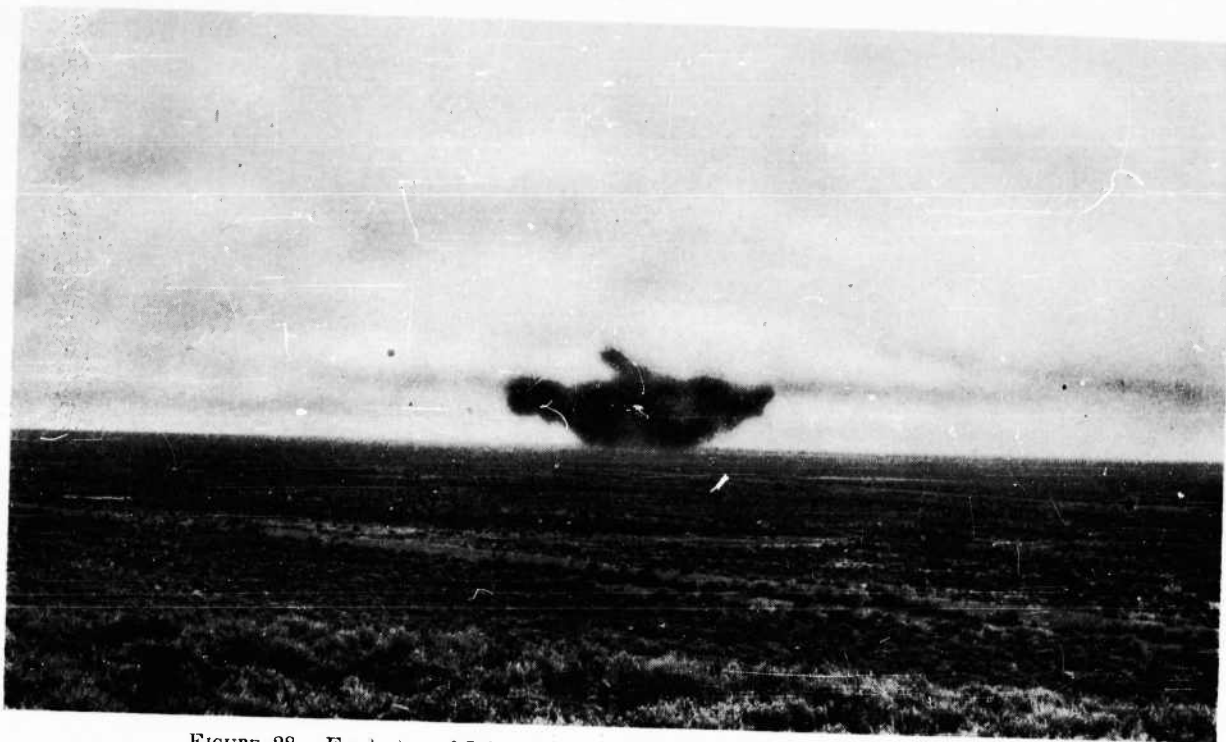
FIGURE 28. Explosion of Igloo D as seen from observation station (early stage)

(b) *High-speed motion pictures.*—The most interesting photographic results were obtained from the Eastman Hi-Speed camera, which produced a film in which the trace of the shock wave was clearly visible as it passed over Igloo E. The effects of the detonation as seen in this film may be described as follows: The instant of detonation was marked by a sudden brightening of the scene, caused by the flash. A few frames later, the shock wave appeared, advancing at high velocity across the field of view. At first it was visible only at points where it intersected the silhouetted outlines of the igloos. The ground surface behind the wave front was obscured by a pall of turbulent, flying dust set in motion by the blast. When the wave struck the sloping earth embanked on Igloo E, it was reflected upward, and a "Mach" wave was formed. The intersection of the incident, reflected, and Mach waves, known as the "triple point" was distinctly visible as the front moved up the slope and over the top of the igloo. At this point, the camera speed as determined from timing marks on the film was approximately 700 frames per second, and the elapsed time from the instant of detonation until the arrival of the shock front at the centerline of the igloo was 0.07 seconds. This corresponds to a velocity of 3,000 ft./sec., assuming the wave originated at the center of the charge at the instant of detonation. This, of course, does not actually occur, as the wave is not developed until the volume of the products of detonation is more than 5 times the original volume. As the shock wave passed the center of Igloo E, its mean velocity was about 2,250 ft./sec. The forward edge of the flame, smoke and dust cloud, in the air above the igloo, moved across the scene at about 1,250 ft./sec. Then came a

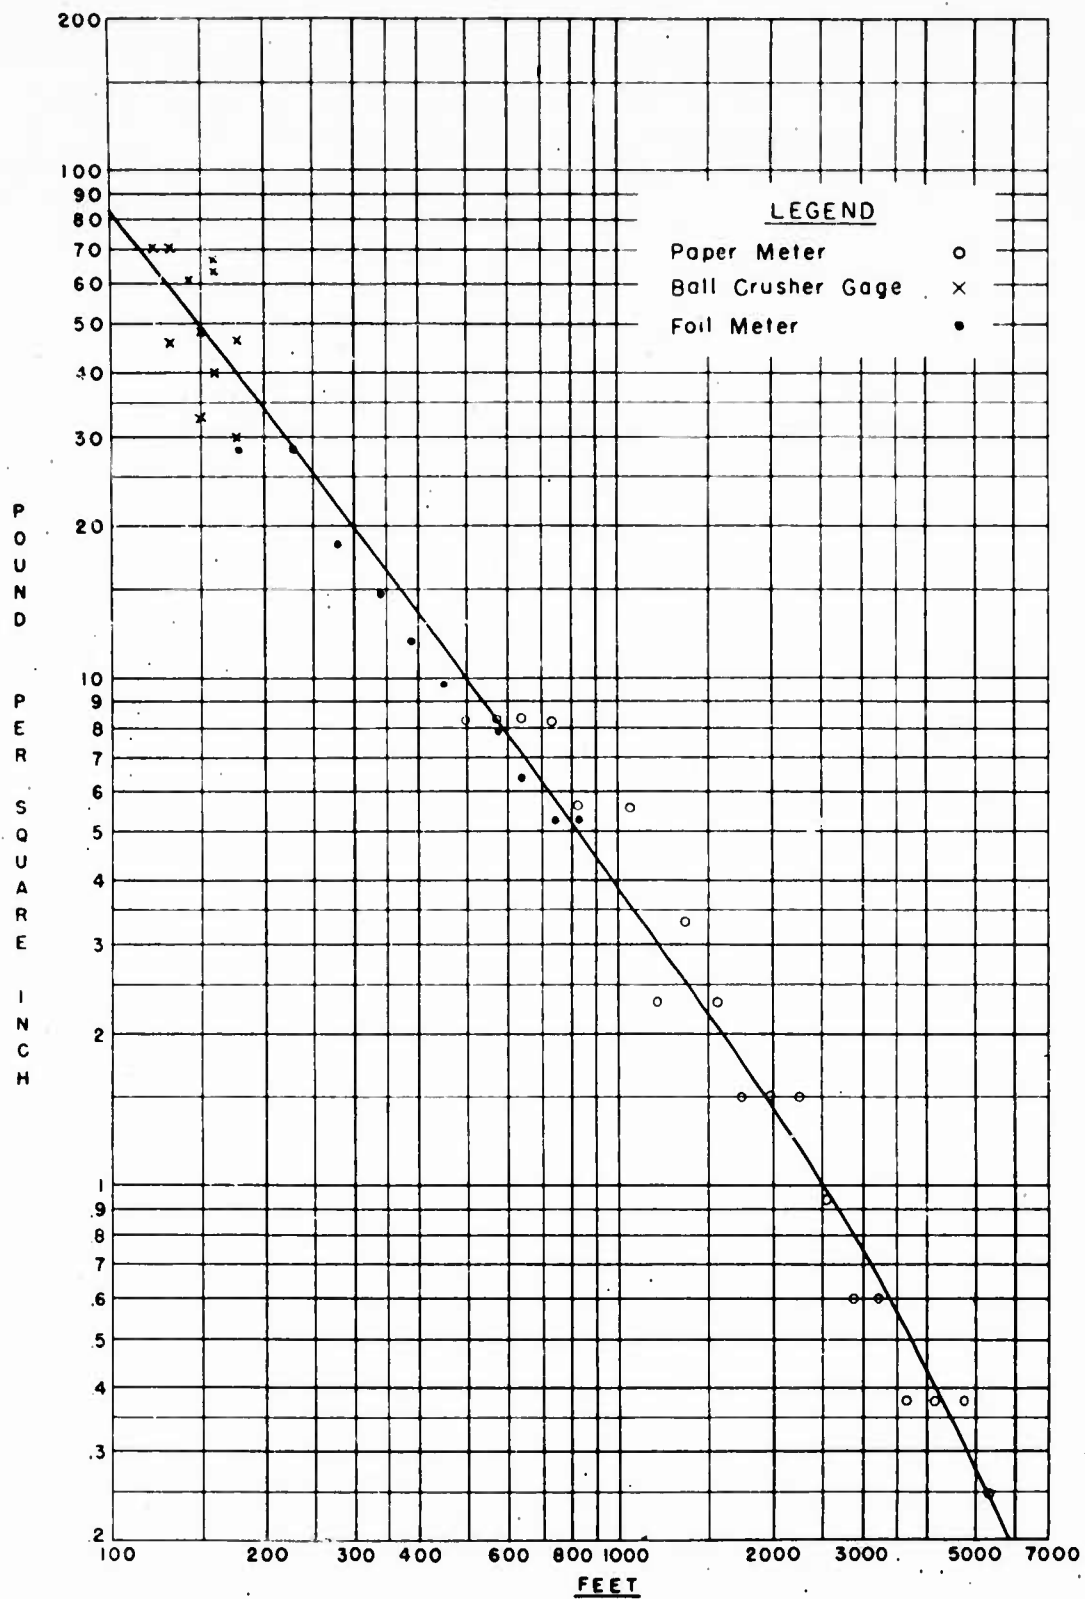
FIGURE 32. Peak Blast Pressure vs Distance from charge, Test 1, Line 1 (Off Front)

(c) *Air blast.*—Peak pressures obtained

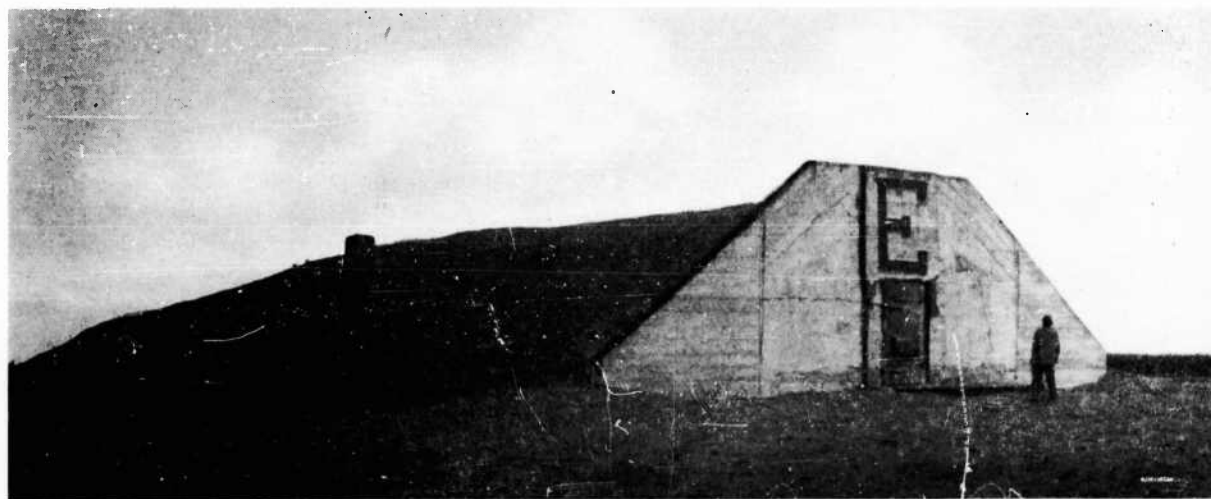
(h) *Damage to target igloos; (1) Igloo E.*— For views of this igloo taken immediately after the explosion, see figures 43 through 46. The photographs show that the igloo stood substantially as it had before the explosion, although the earth cover was dishevelled and the concrete ventilator blasted askew. Measurements of the depth of earth cover over the crown disclosed that near the rear of the igloo, earth had descended from the debris cloud and actually increased the thickness of cover. Adjacent to the headwall, however, about 6 inches of earth had been blown off. On opening the door, it was found that the bomb stacks had not been disturbed or displaced in any manner whatsoever. The headwall suffered severe cracking, mostly above 6 feet from the ground, and was displaced outward, its bottom edge being entirely separated from the floor slab on the inside, leaving a gap about 2" wide on the near side (toward the explosion) and 1" wide on the far side. The circumferential joint between the arch barrel and headwall was ruptured with much spalling; this was most severe on the near side. The main cracks in the wall went through from inside to out and were open up to about  $\frac{1}{2}$ ". At points where cracks branched, there was considerable spalling. There was bad spalling of concrete on the pilasters on the outside face, and the reinforcing was exposed in several places. The door, which was 4'  $5\frac{3}{8}$ " wide by 8'  $1\frac{1}{4}$ " high and built up of  $\frac{5}{8}$ " steel plate with an asbestos blanket under a  $\frac{1}{8}$ " cover plate on its inner

FIGURE 43. Three-quarter front view of Igloo E after Test 1

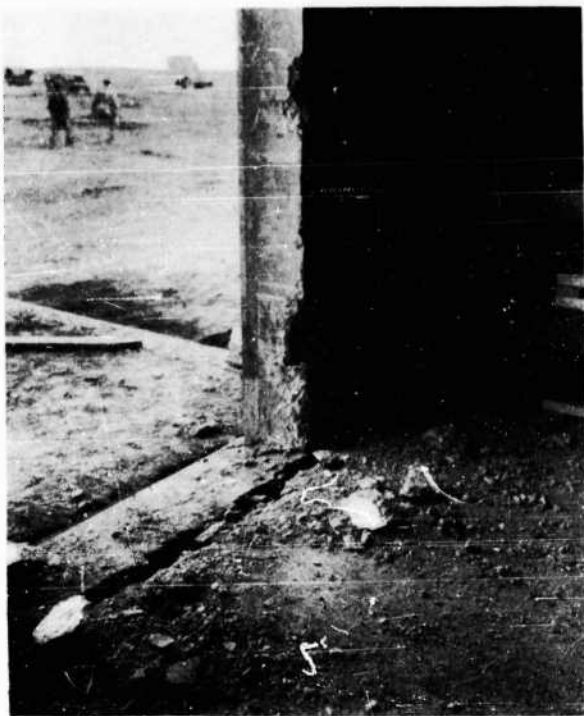
FIGURE 46. View from inside Igloo E after Test 1, showing separation of front wall from door slab.

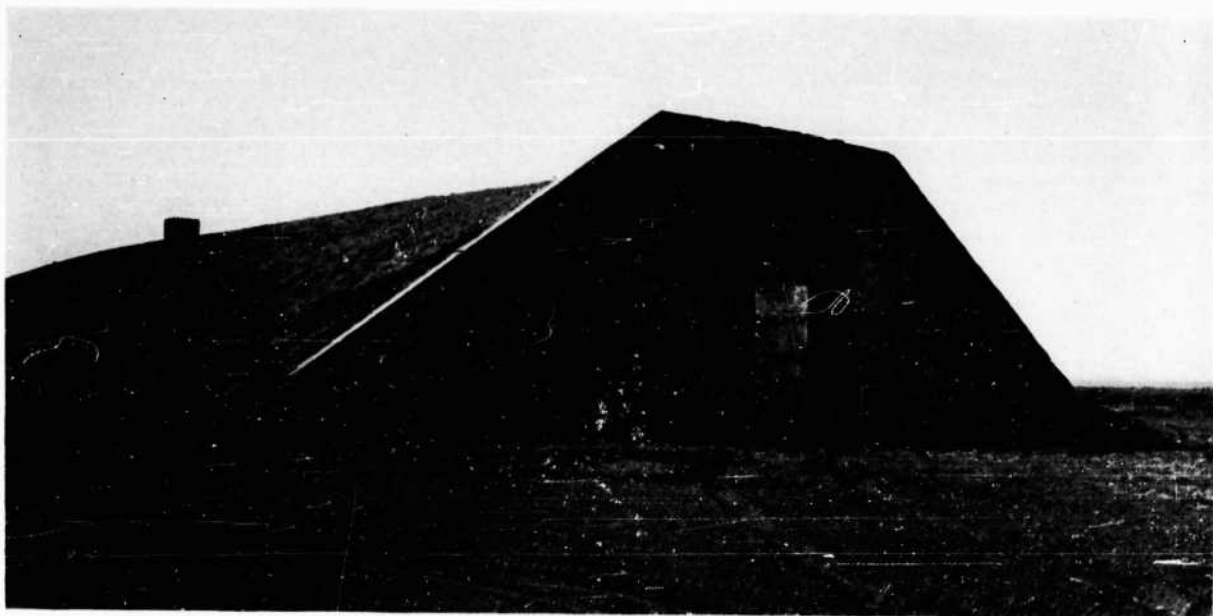
FIGURE 47. Three-quarter front view of Igloo F after Test 1

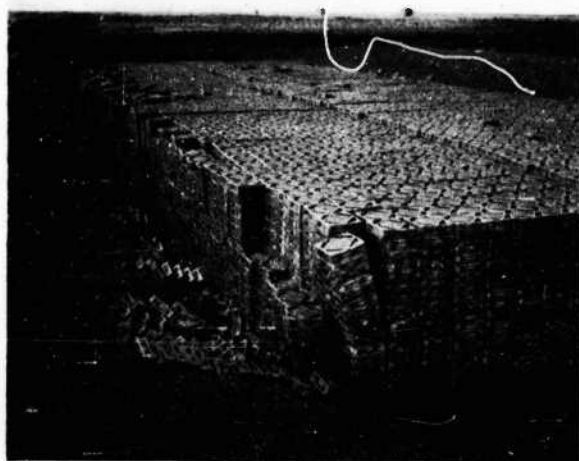
figures 49 through 52. Apparently the suction phase of the blast was responsible for the toppling over of the middle third of the first tier of mines on the near side of the pile, the collapse of the corners of the stack and the wide scattering of individual mines. Twenty-one mines were counted on the ground on the near side of the revetment, the farthest lying about 40 feet from the edge of the stack, and 32 mines lay on the upper part of the windrow.

FIGURE 50. Revetment 1 after Test 1, looking northeast from southwest corner

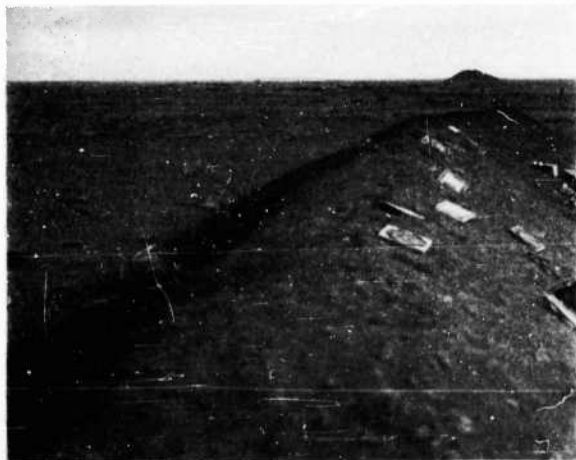
FIGURE 52. Revetment 1 after Test 1. Looking north along top of west windrow

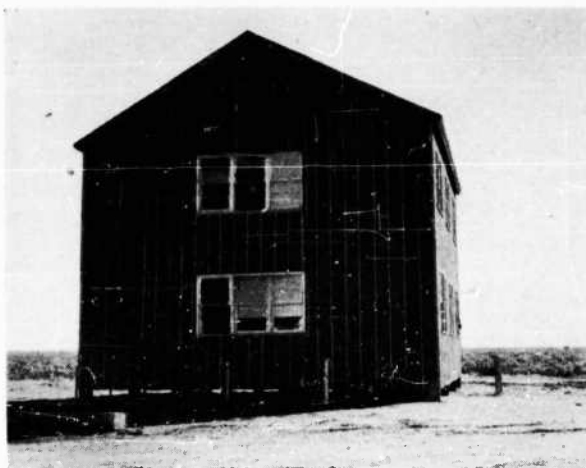
FIGURE 58. North elevation of Barracks 2 after Test 1

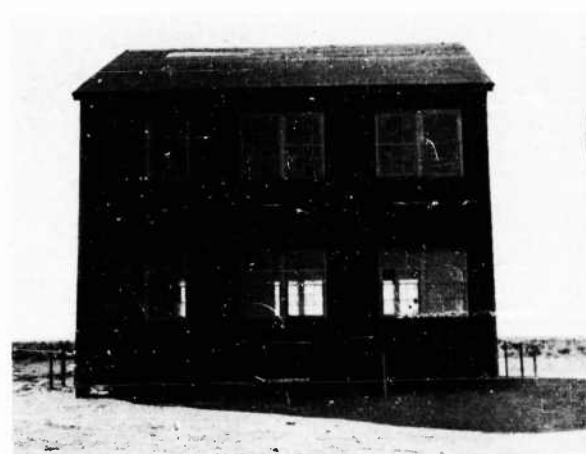
FIGURE 61. East elevation of Barracks 3 after Test 1

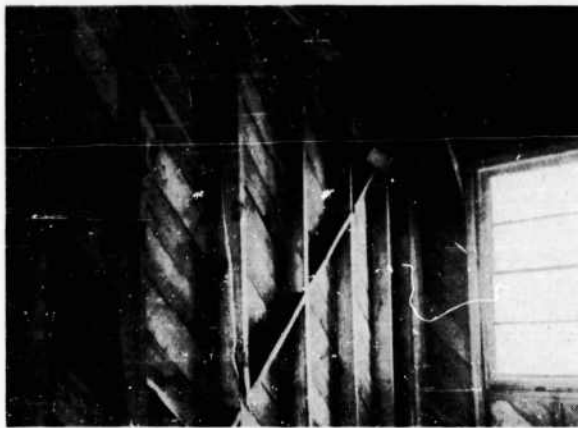
FIGURE 75. Interior, Barracks 3 after Test 1. Broken stud in north wall, second story

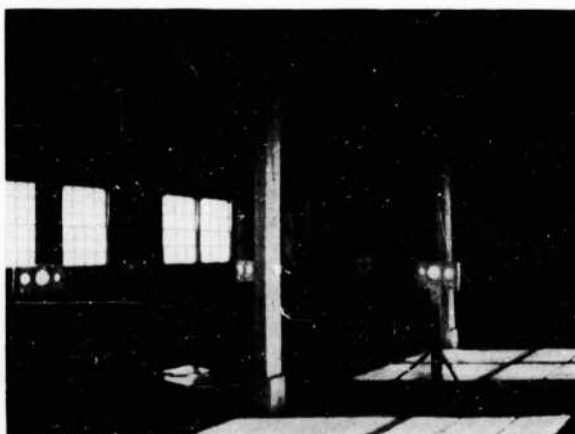
FIGURE 77. Interior, Barracks 3 after Test 1. Looking southeast on second floor

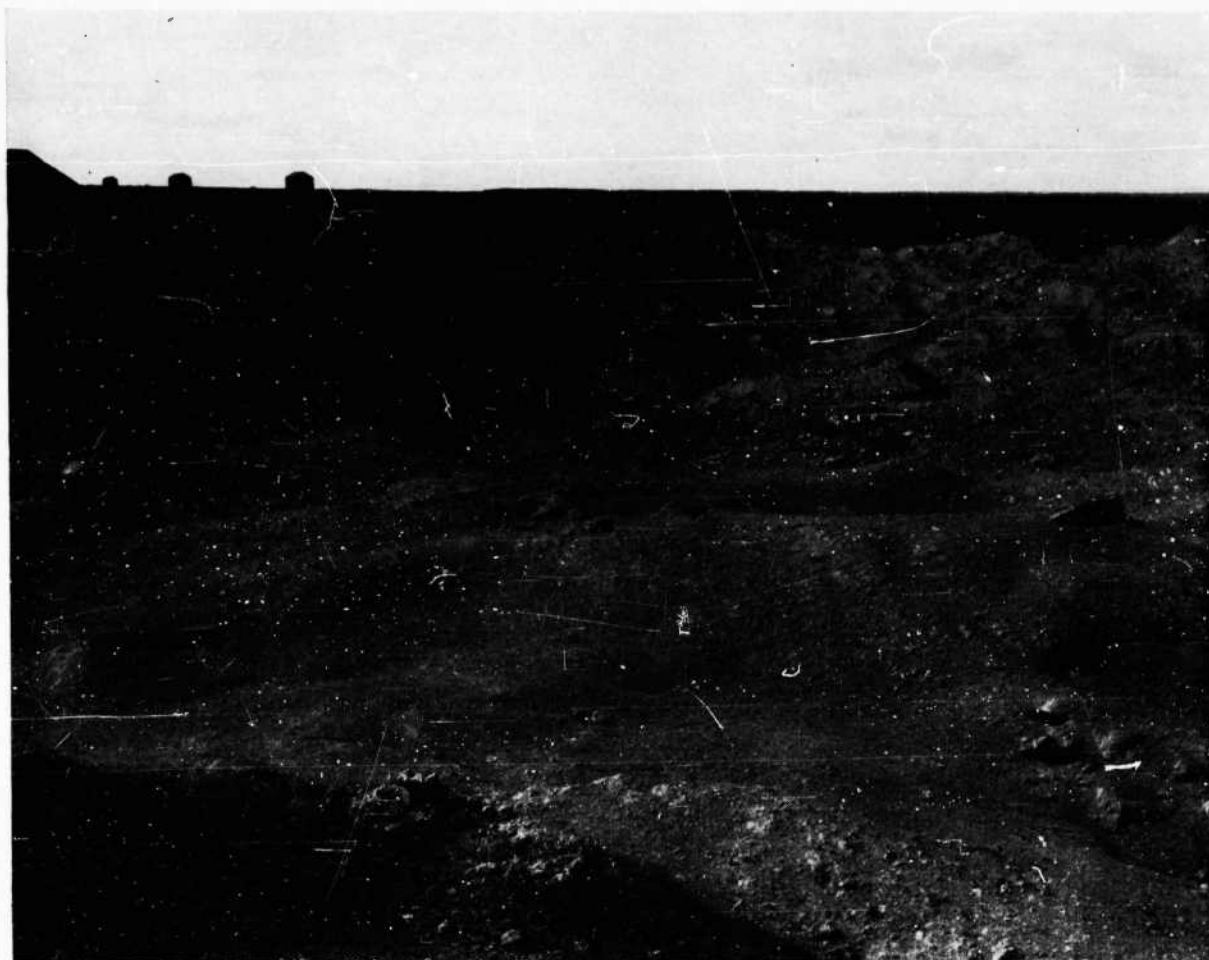
(d) *Crater*.—In plan, this crater was nearly circular, the north-south and east-west apparent diameters differing by only about 2 feet. The average diameter was 177 feet, and the maximum depth was 10 feet. This crater appeared much shallower than that of Igloo D, and had a more uneven bottom with many heaped-up places. The rim of this crater did not quite meet the rim of the first crater, the space left between the two being wide enough for a jeep to drive through. For plan and profiles of this crater, see figure 91. For photographs, see figures 92 and 93, which illustrate the unevenness of the bottom and the distribution of concrete fragments. Excavation at the deepest point of the bottom disclosed that the true depth was from 2 to 2½ feet greater than the apparent depth. The excavation was car-

FIGURE 93. Crater of Igloo E, looking southwest

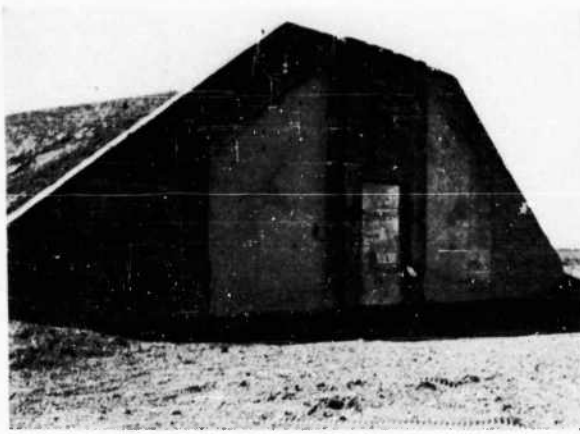
in numerous places, leaving indentations up to a foot in diameter, but no missiles penetrated through the wall. The pilasters on either side of the door suffered severe spalling of the concrete, as may be seen from figures 98, 99, and 100. The failure of the front wall was such that it belled inward about 2 inches in the middle (note edge view in figure 99). Three of the principal cracks reached the top of the wall and a scab or broken piece of concrete was dislodged from the top edge (see figures 101 and 102). The door and frame were bent inward slightly but were in operating order when the igloo was opened. The bottom hinge anchor was nearly torn out of the pilaster, as

FIGURE 97. Front of Igloo F after Test 2

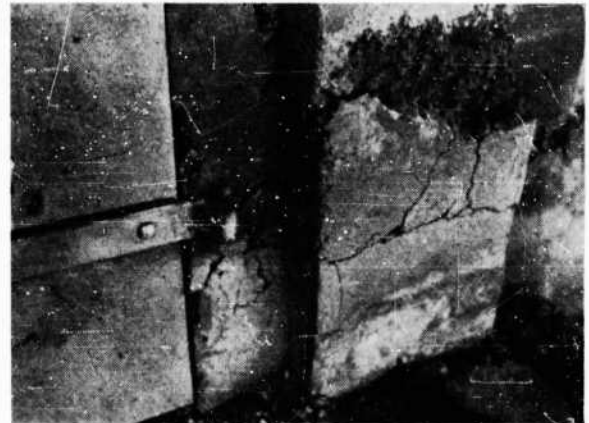
FIGURE 100. Close-up of lower door hinge and pilaster, showing fractured concrete over hinge anchor; Igloo F after Test 2

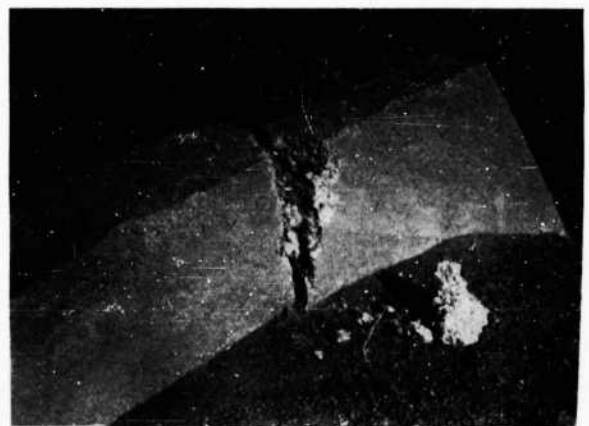
FIGURE 102. Close-up of crack and "scab" from rear of upper edge of front wall; Igloo F after Test 2

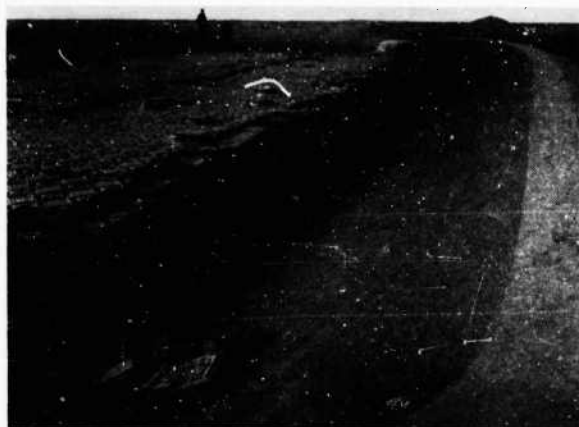
FIGURE 103. Revetment 1 after Test 2, looking north from southeast corner

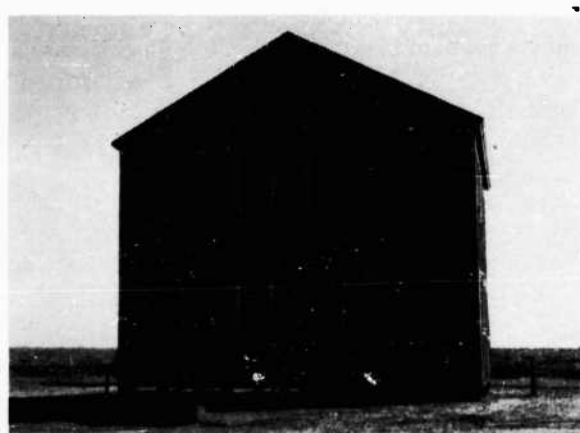
FIGURE 110. North elevation of Barracks 2 after Test 2

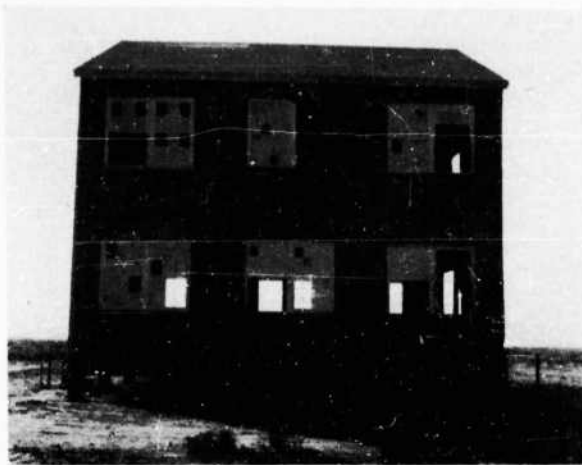
FIGURE 111. East elevation of Barracks 2 after Test 2

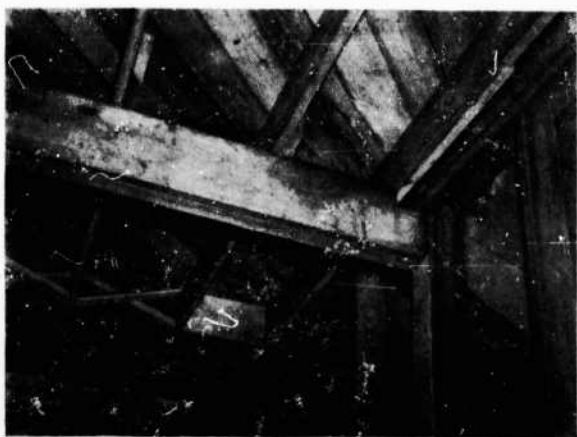
FIGURE 120. Displacement of south wall and column supporting 2nd floor, ground floor, Barracks 1 after Test 2

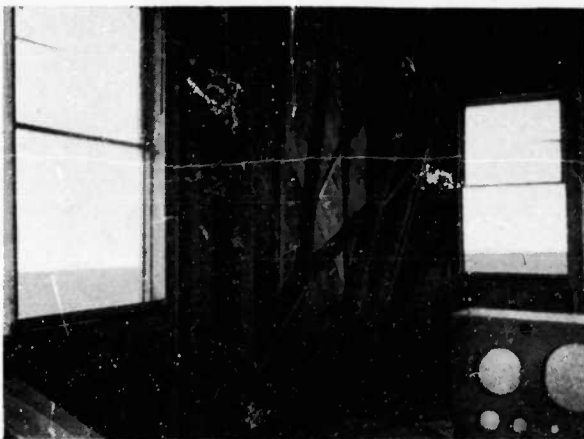
FIGURE 123. Damage in northeast corner of ground floor, Barracks 2 after Test 2

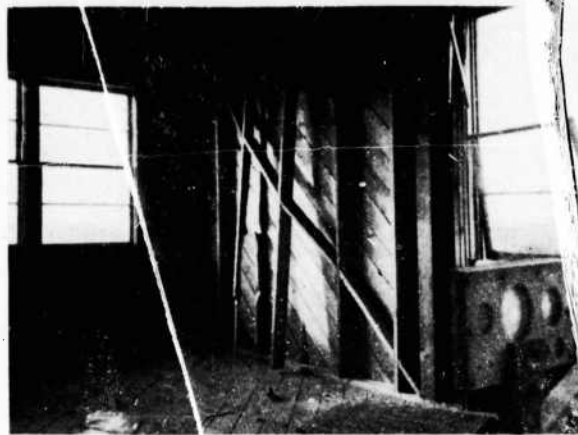
FIGURE 124. Broken studding in west part of north wall, ground floor, Barracks 2 after Test 2

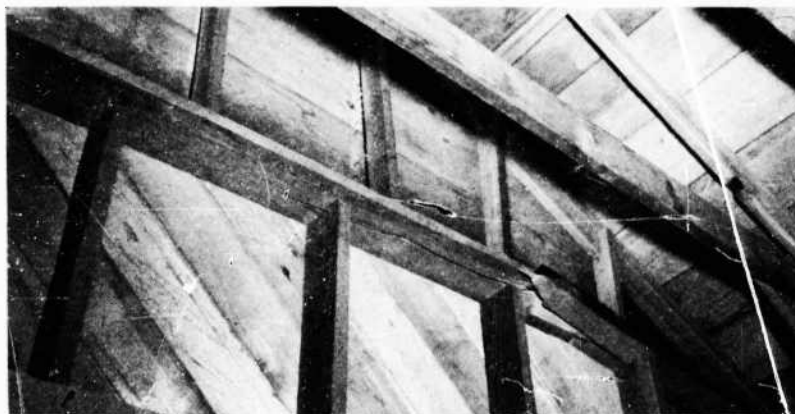
FIGURE 125. Broken stud and plate in north wall, second floor, Barracks 2 after Test 2

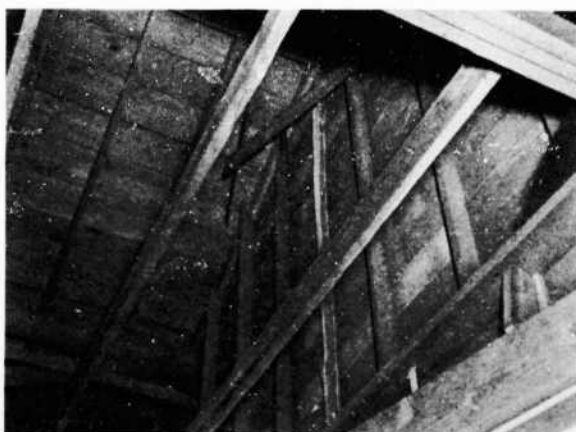
FIGURE 126. Broken studs in north gable, Barracks 2 after Test 2

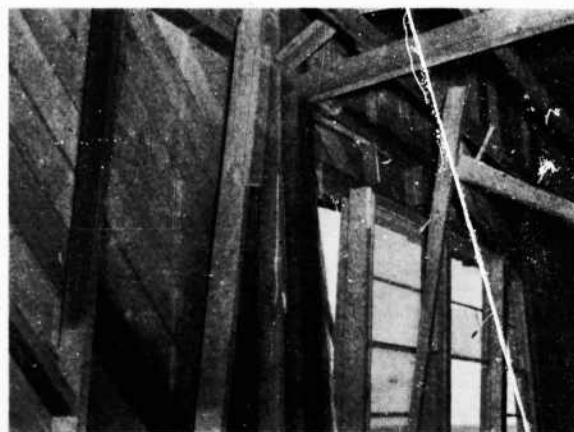
FIGURE 127. Broken and displaced studs, north wall, second story, Barracks 2 after Test 2

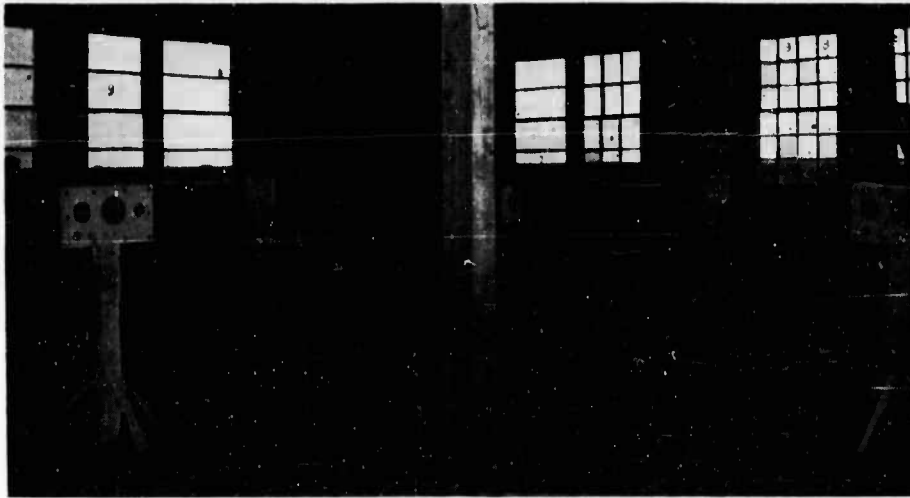
FIGURE 129. Interior of lower story, looking northeast, Barracks 3 after Test 2

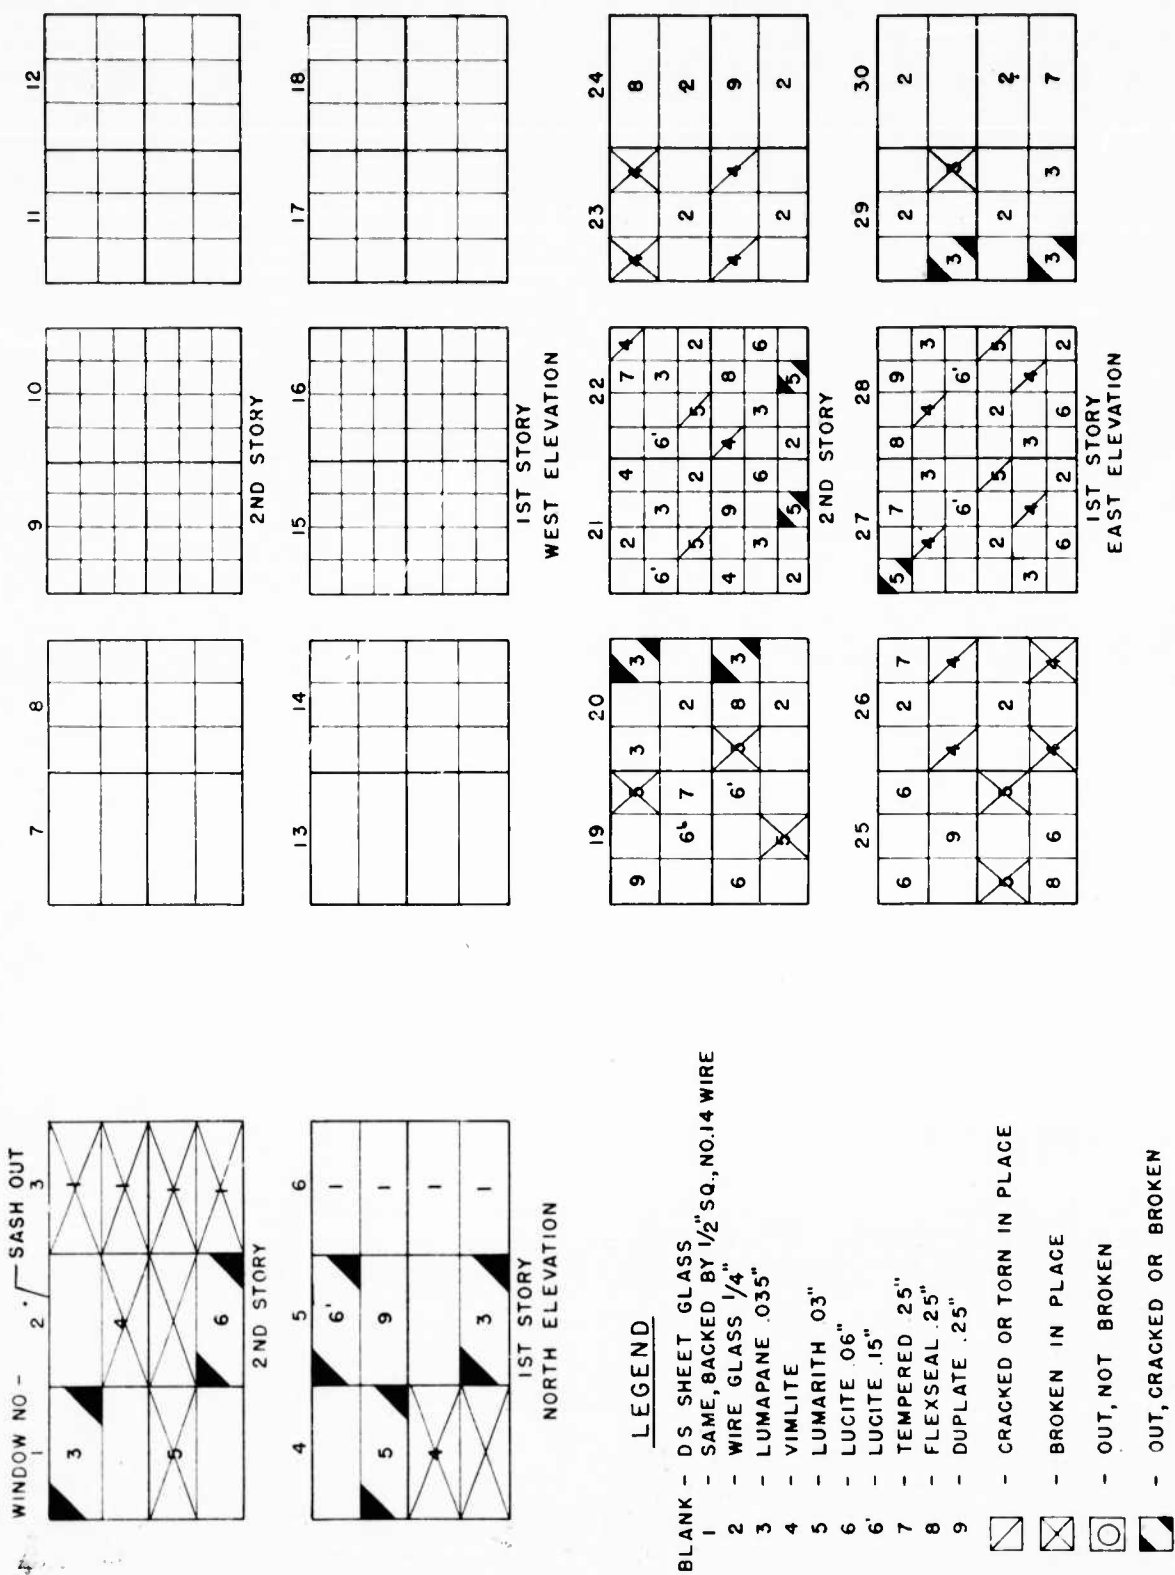
FIGURE 133. Glass Damage, Barracks 3, Test 2

*Barracks 3.*—On the north elevation, four panes of DS glass backed by wire mesh and one with no backing were demolished in place. On the east side, three  $11\frac{5}{8}$ " x  $14\frac{3}{4}$ " pieces and two  $8\frac{5}{8}$ " x  $9-11/16$ " pieces of Vimlite were either torn loose, left hanging, or were completely missing. One light of Lumapane  $11\frac{5}{8}$ " x  $14\frac{3}{4}$ " in size and one small pane of the same material were blown in. Figure 133 gives the total glass damage to this building following test 2.

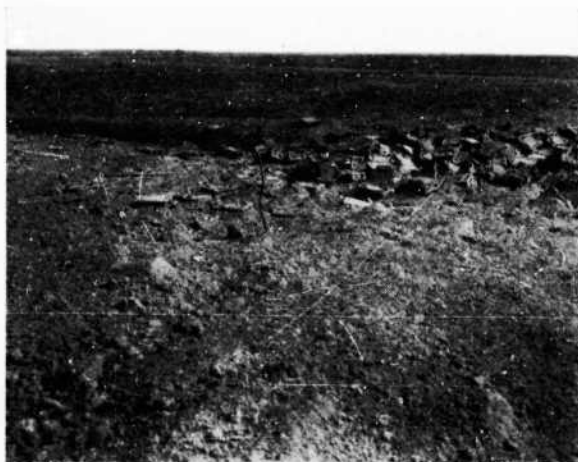
FIGURE 149. Revetment 2 after Test 3, looking east from west side

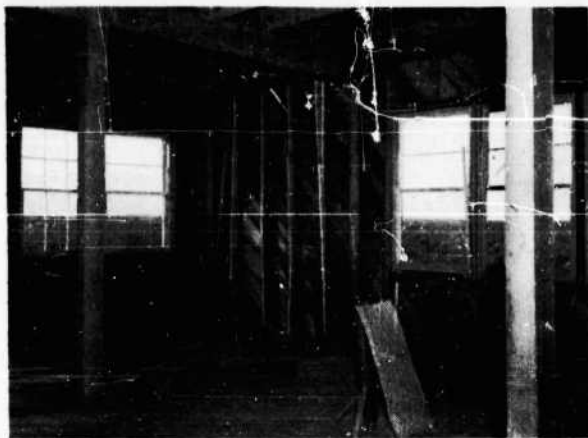
FIGURE 163. Interior, Barracks 1 after Test 3, showing broken studding, northwest corner, ground floor

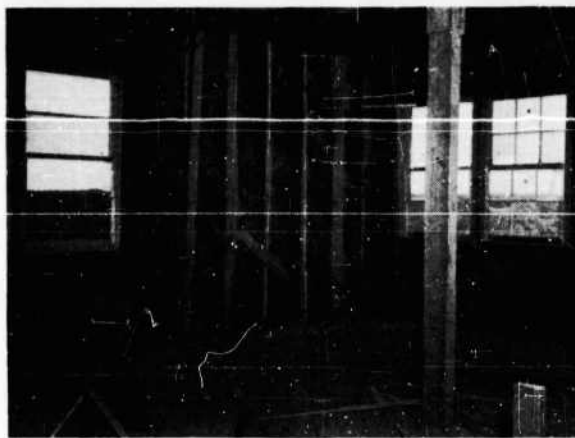
FIGURE 164. Interior, Barracks 1 after Test 3, showing broken studding, northeast corner, ground floor

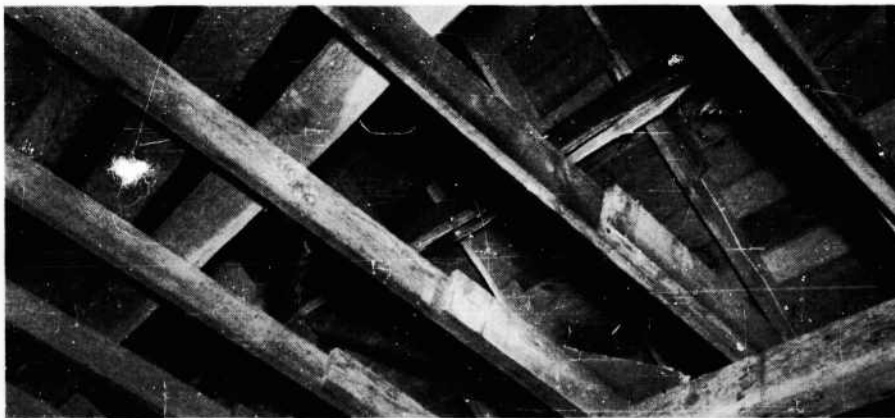
FIGURE 167. East section of roof framing, Barracks 1 after Test 3, showing broken purlin

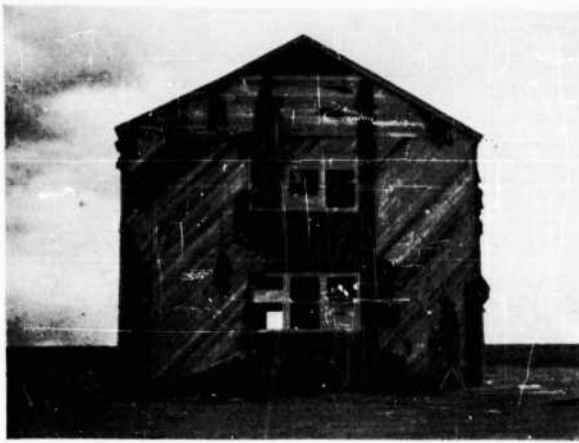
FIGURE 183. Barracks 1 after Test 4;  
north elevation

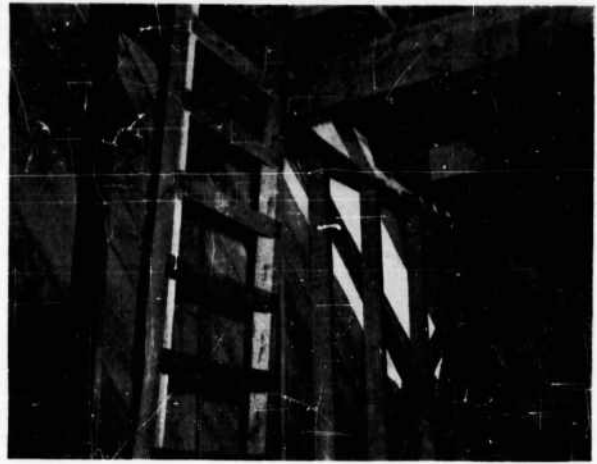
FIGURE 196. Interior of Barracks 1 after Test 4, showing separation of south wall from second floor, and missing sheathing

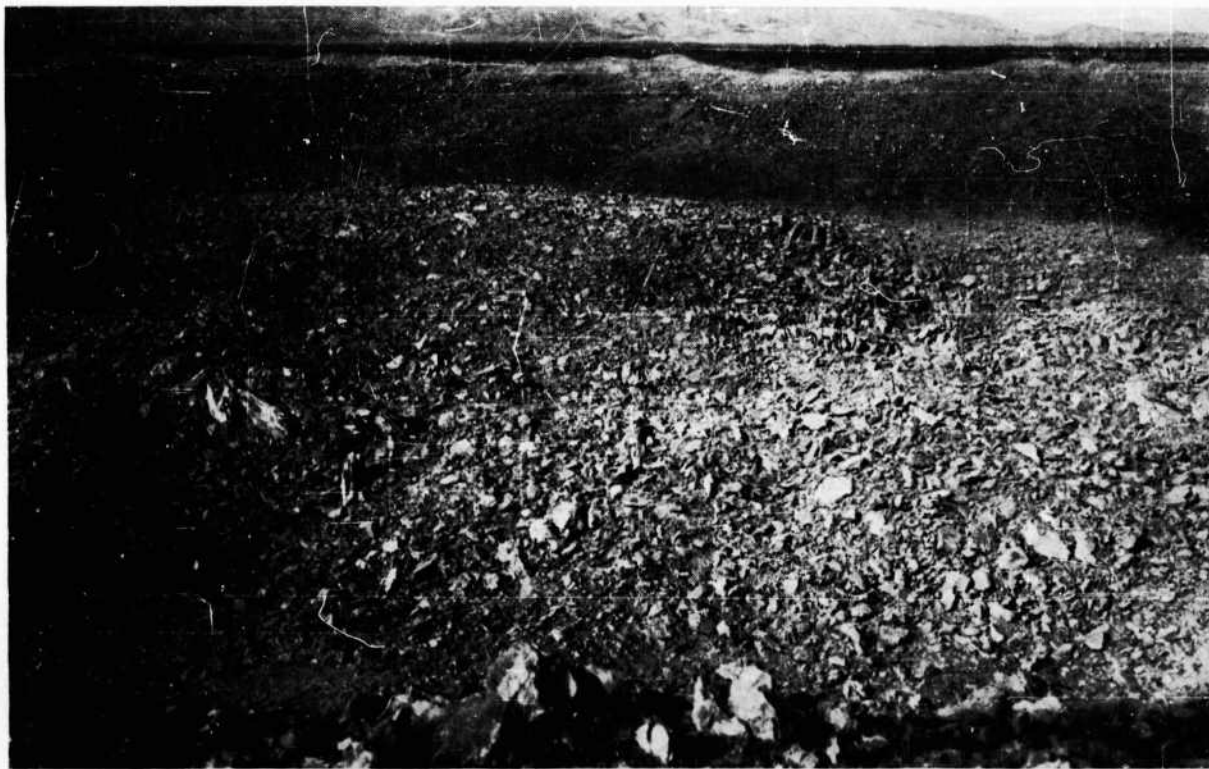
FIGURE 203. Crater of Revetment 2, looking west from east rim

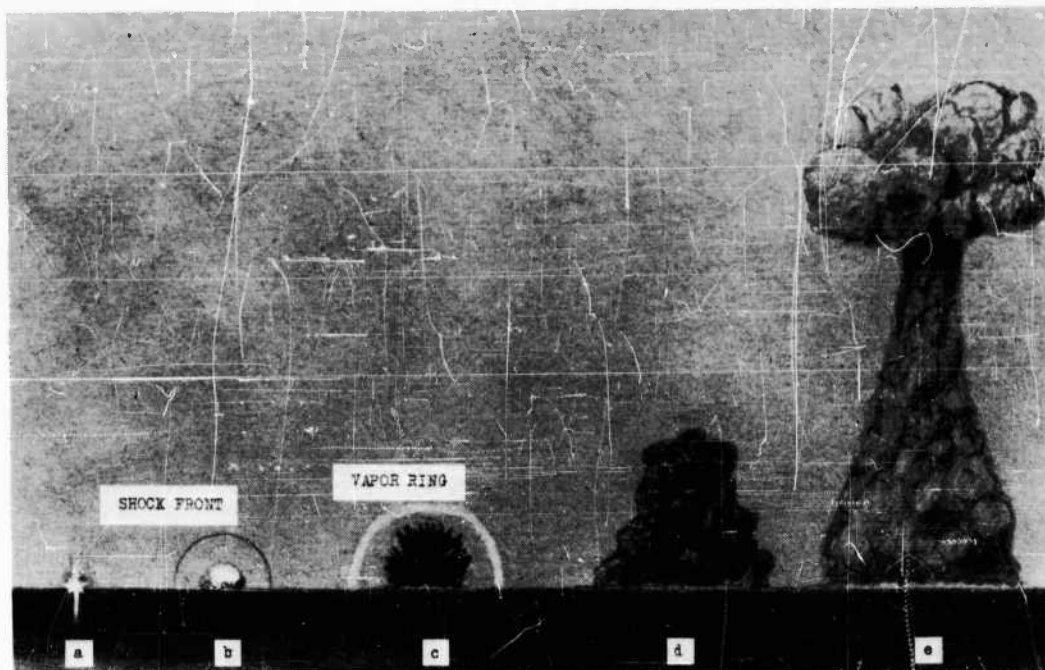
(c) *Effect on explosion when charge is stored in igloo with augmented earth cover.*—The effect of twice the standard amount of earth on the exploding igloo is to increase the breadth of the base of the cloud still further. Although the head of the cloud is not changed, it rests upon a fat pyramidal base without any intervening stem or neck. The maximum diameter

FIGURE 222. Forms of an idealized igloo explosion

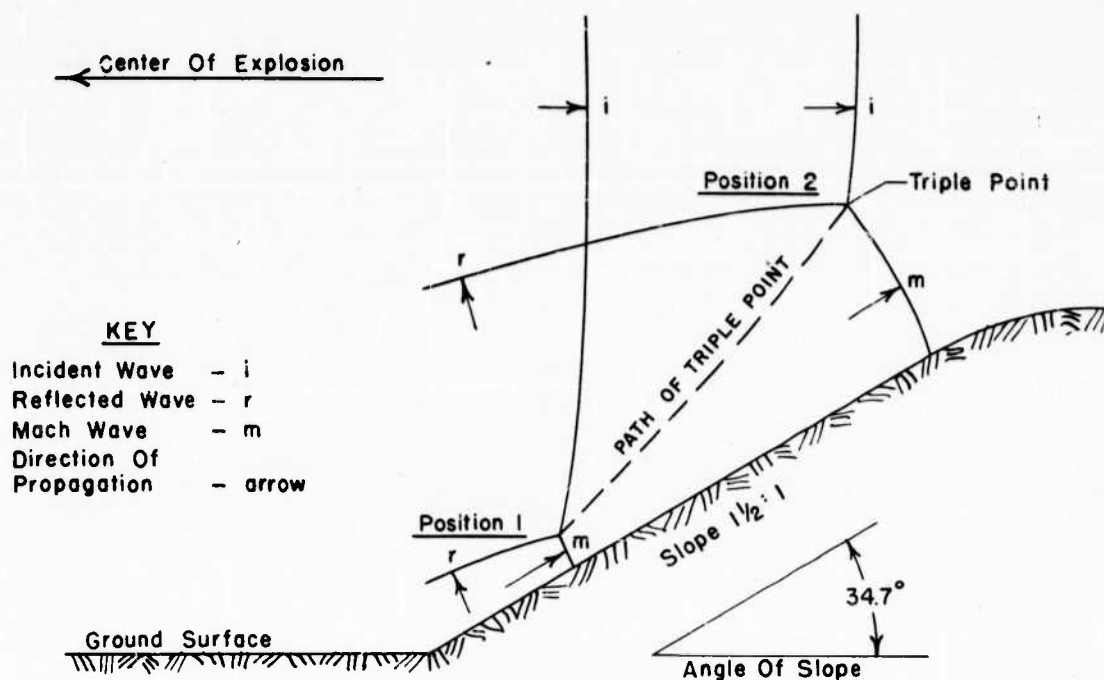
FIGURE 223. Mach reflection on sloping earth embankment of target igloo

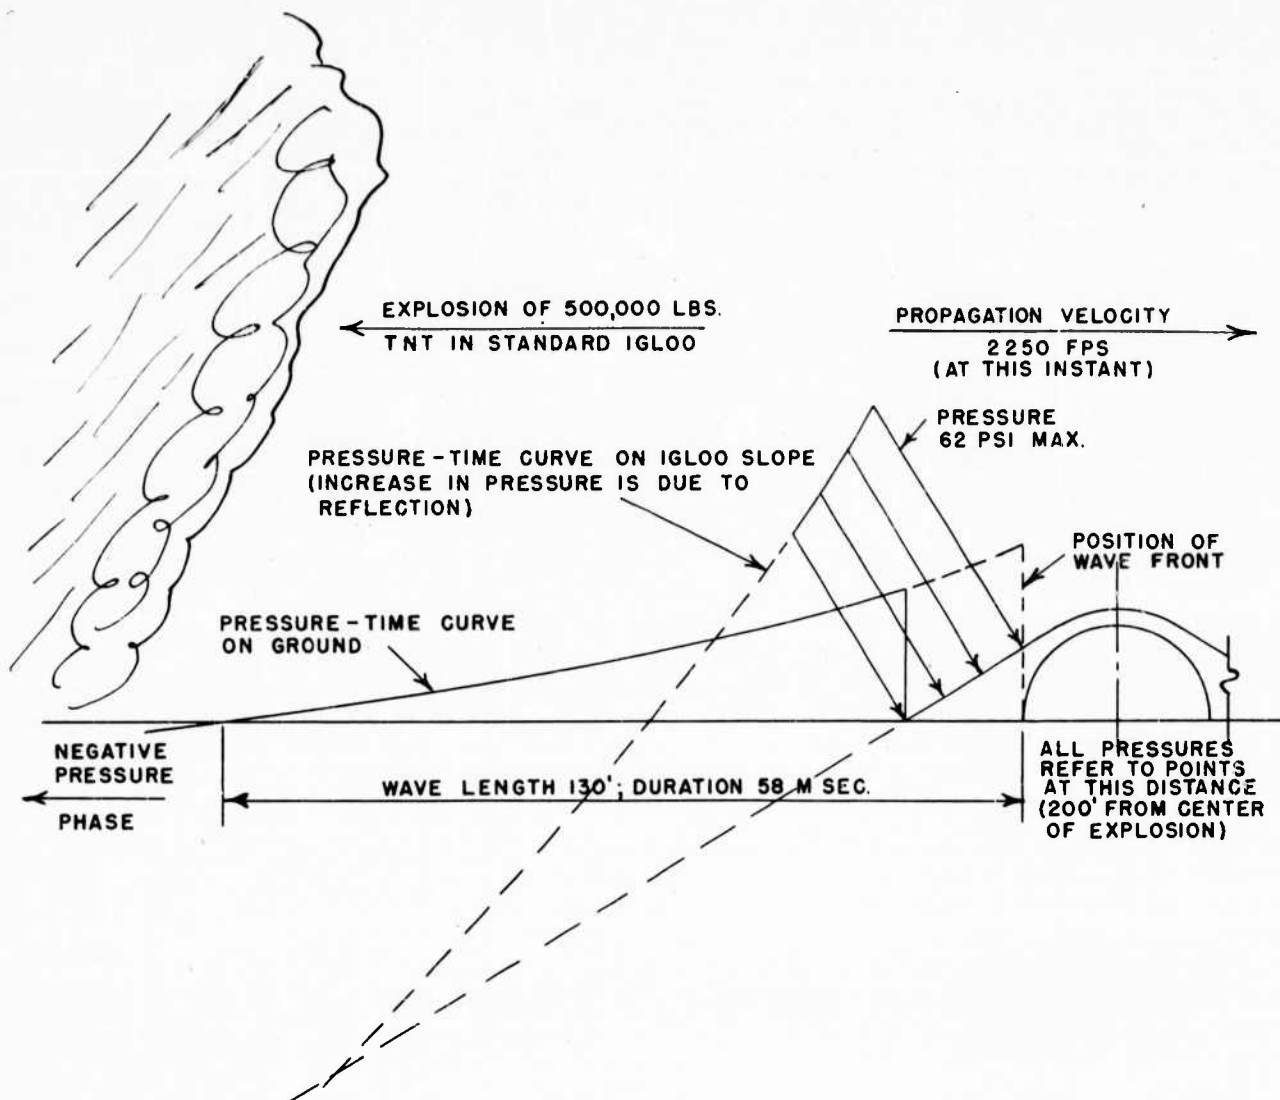
FIGURE 224. Blast loading on near side of igloo
